*A Report on the*  
**AIRLIFT**  
*Berlin Mission*

**THE OPERATIONAL AND  
INTERNAL ASPECTS OF  
THE ADVANCE ELEMENT**

PREPARED BY HEADQUARTERS  
COMBINED AIRLIFT TASK FORCE

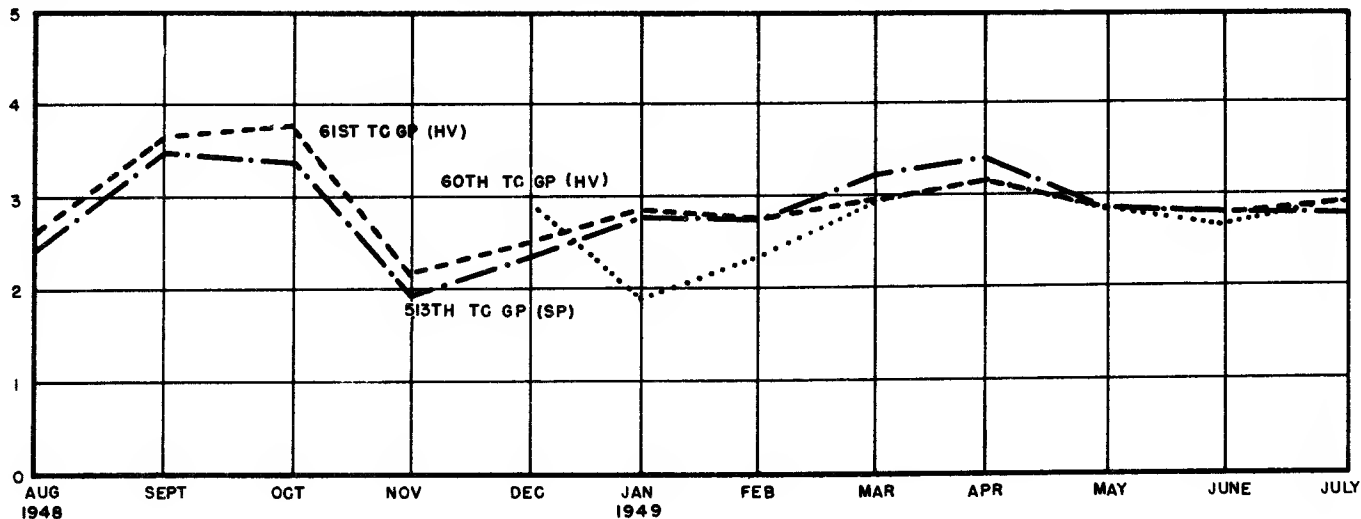
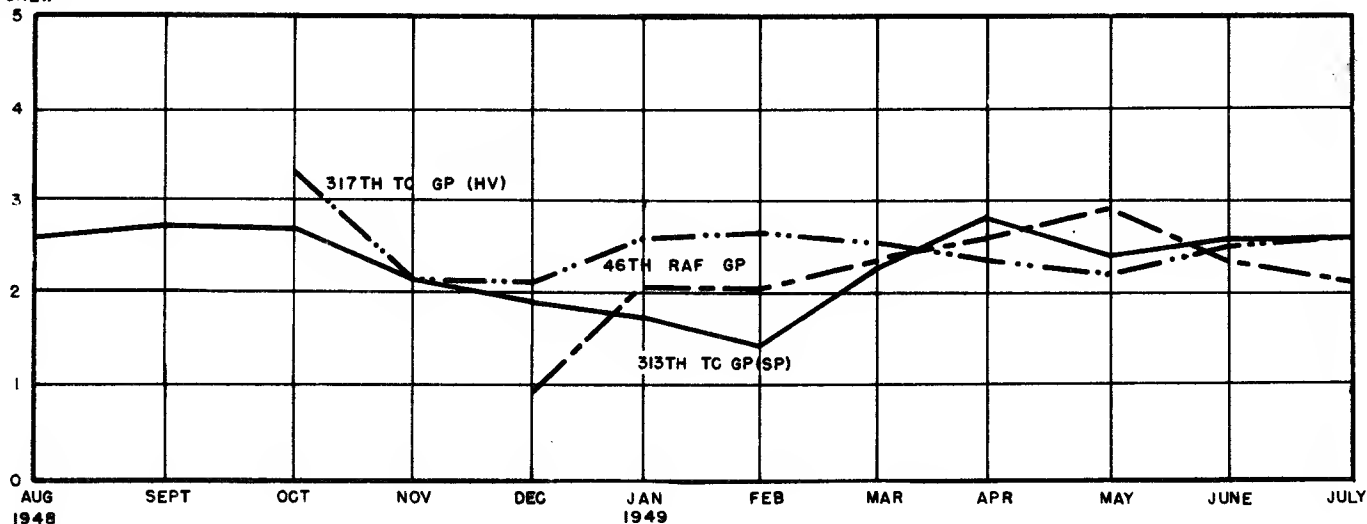
### GROUP CREW UTILIZATION

After the early periods of trial and error, a fairly stable air crew utilization of a little better than  $2\frac{1}{2}$  hours per day was reached by both the

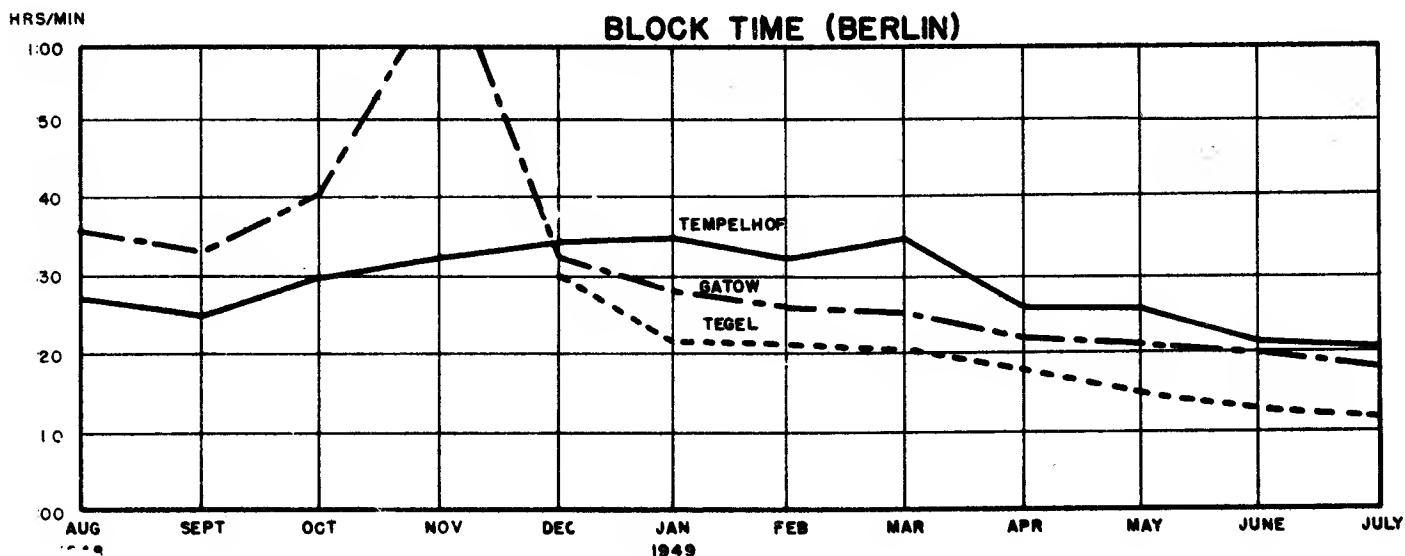
### BLOCK TIME (BERLIN)

The statistics on the ground time of operational aircraft at the Berlin receiving airports reveal an interesting trend downward in the three main categories of turn-around time, block time and unloading time. At these airfields, by July 1949, the turn-around time had been brought to an average of approximately 32 minutes, block time
